PRELIMINARY AUDIT OF GIRARD STATE FOREST COMPARTMENTS 44, 45, 46, 54, 55 and 56

Dailan Pugh, August 2010 For North East Forest Alliance

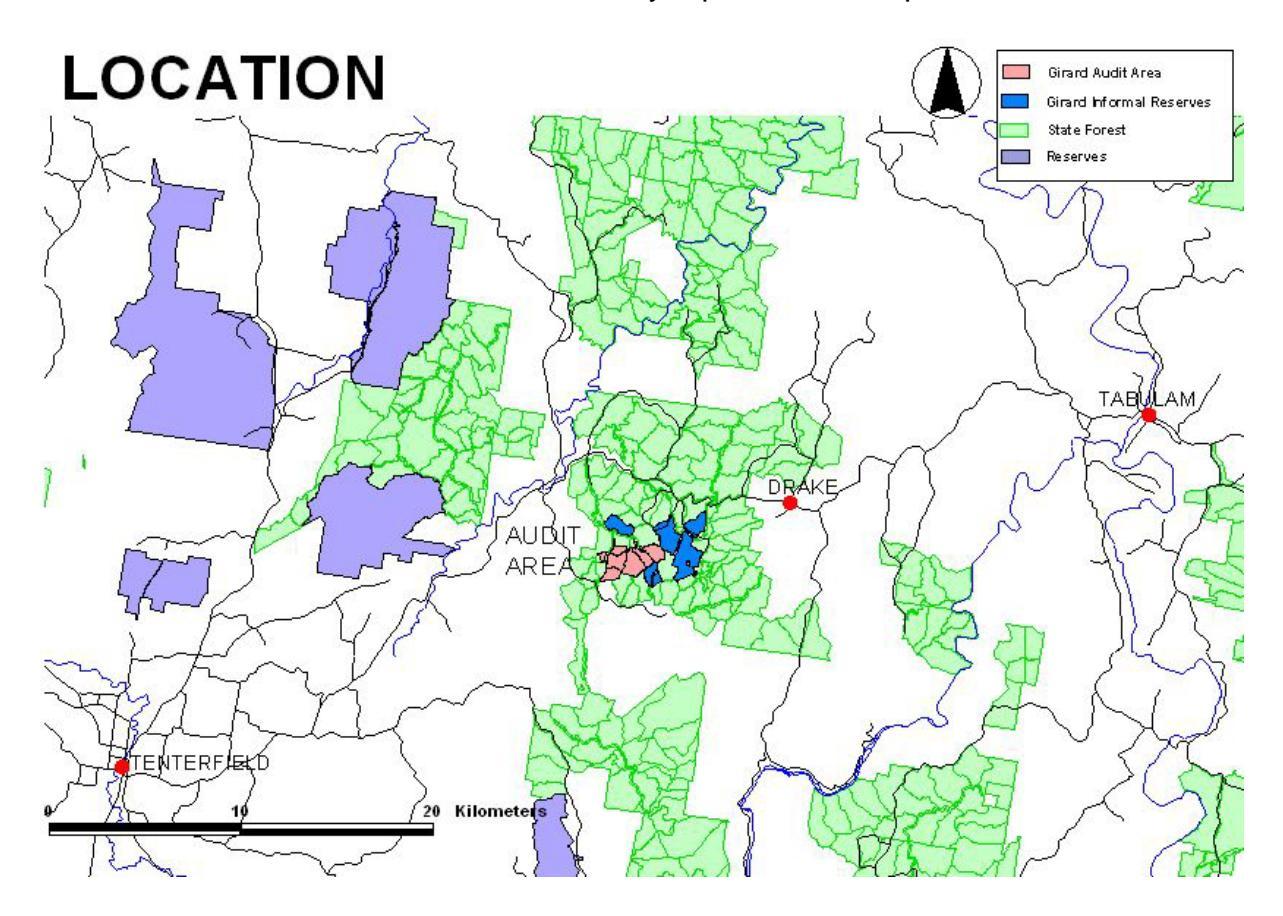
The audited compartments encompass 515ha in Girard State Forest, to the west of Drake in the upper catchment of the Clarence River valley in north-east NSW. Of this area, 333 hectares are available for logging. Detailed audits were only undertaken of 6 ha, representing less than 2% of the total loggable area, though incidental observations were made elsewhere. It is emphasised that only a small part of the area was inspected and that therefore the breaches identified herein only represent a sample of those that occurred.

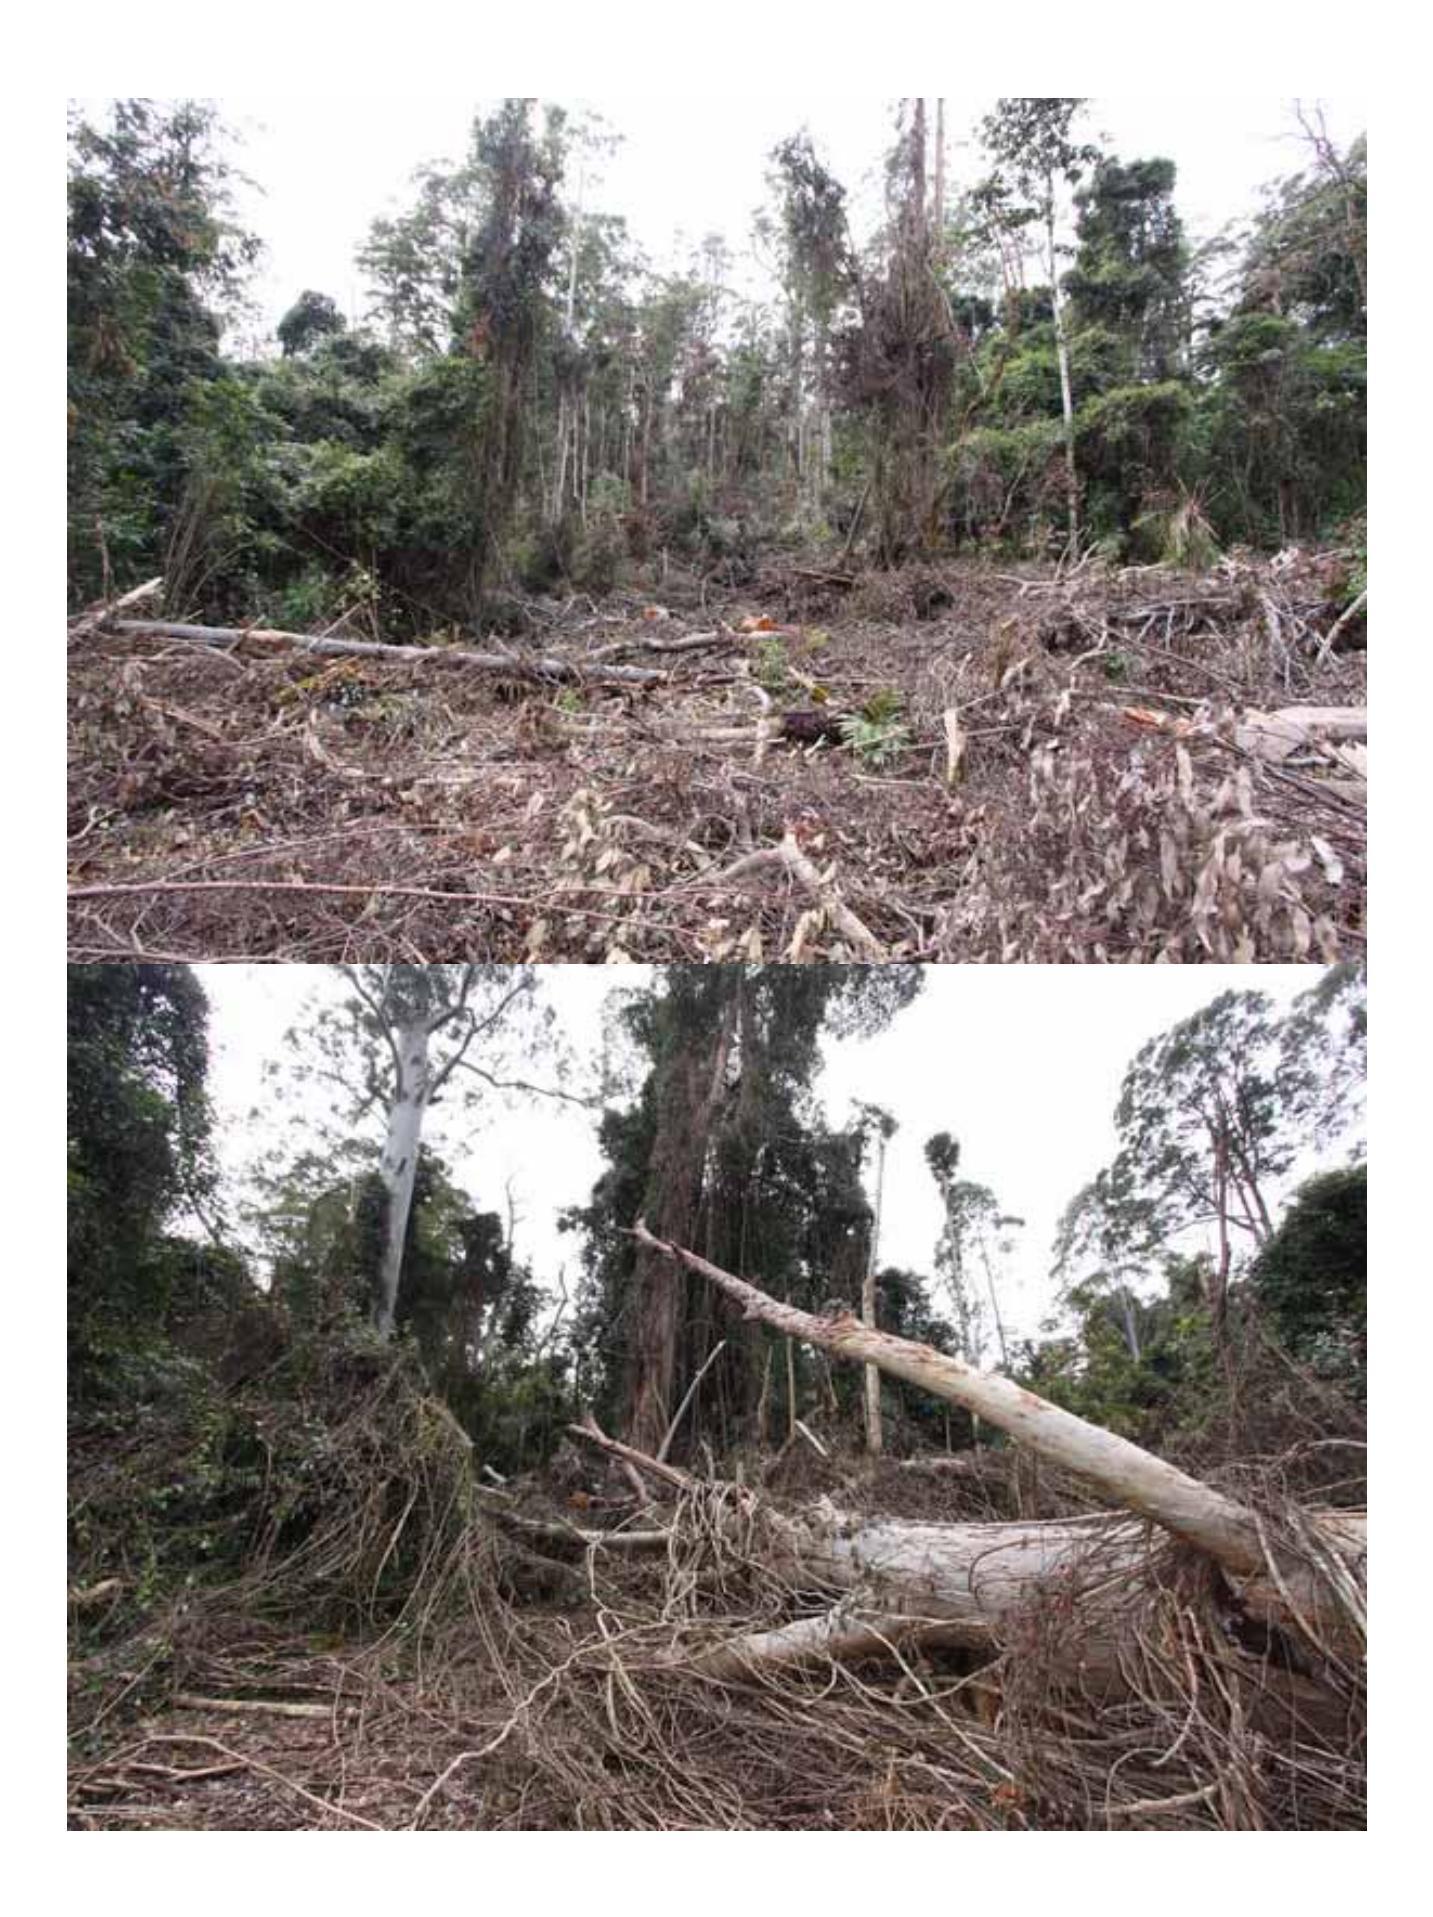
PHOTOS 1&2: Trees dropped across boundaries of FMZ3A areas adjacent to the FMZ3B area in Compartment 44. Note that in the first photo the boundary of the exclusion area seems to have been incorrectly marked in this locality and this may be why the breach occurred. At the second site poor felling appears to be responsible (note the exclusion markings on the sapling in the centre of the photo).

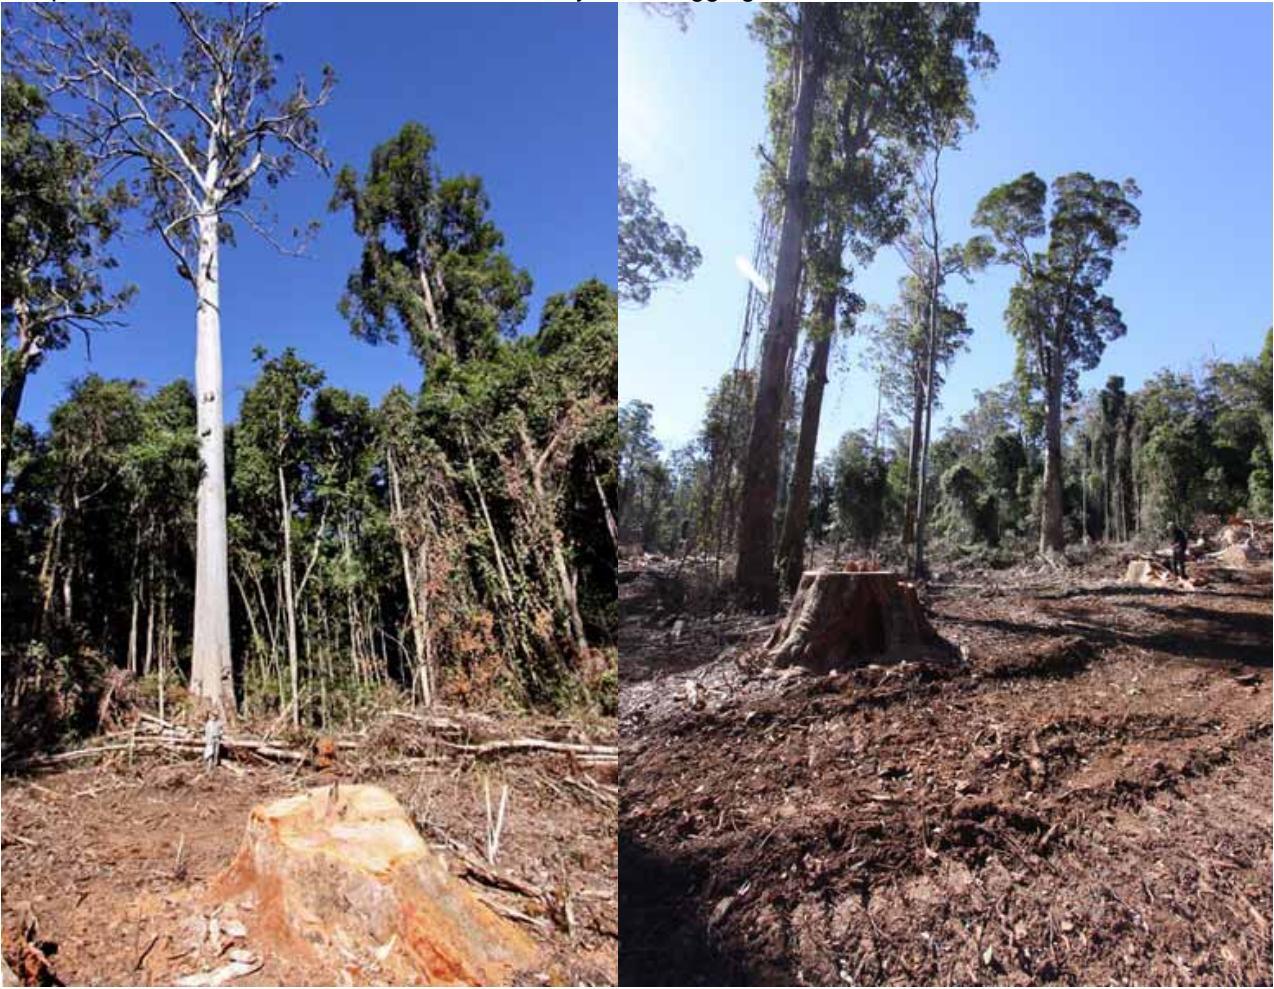
PHOTOS 3&4: Retained trees from the oldgrowth stand. All the largest trees (over 1.4m diameter) were required to be retained to satisfy standardl logging prescriptions, though 40% were logged. Note the debris pushed against the 2.0 m diameter Blue Gum and rainforest exclusion area ready for burning, and the almost complete destruction of the rainforest understorey in the logging area.

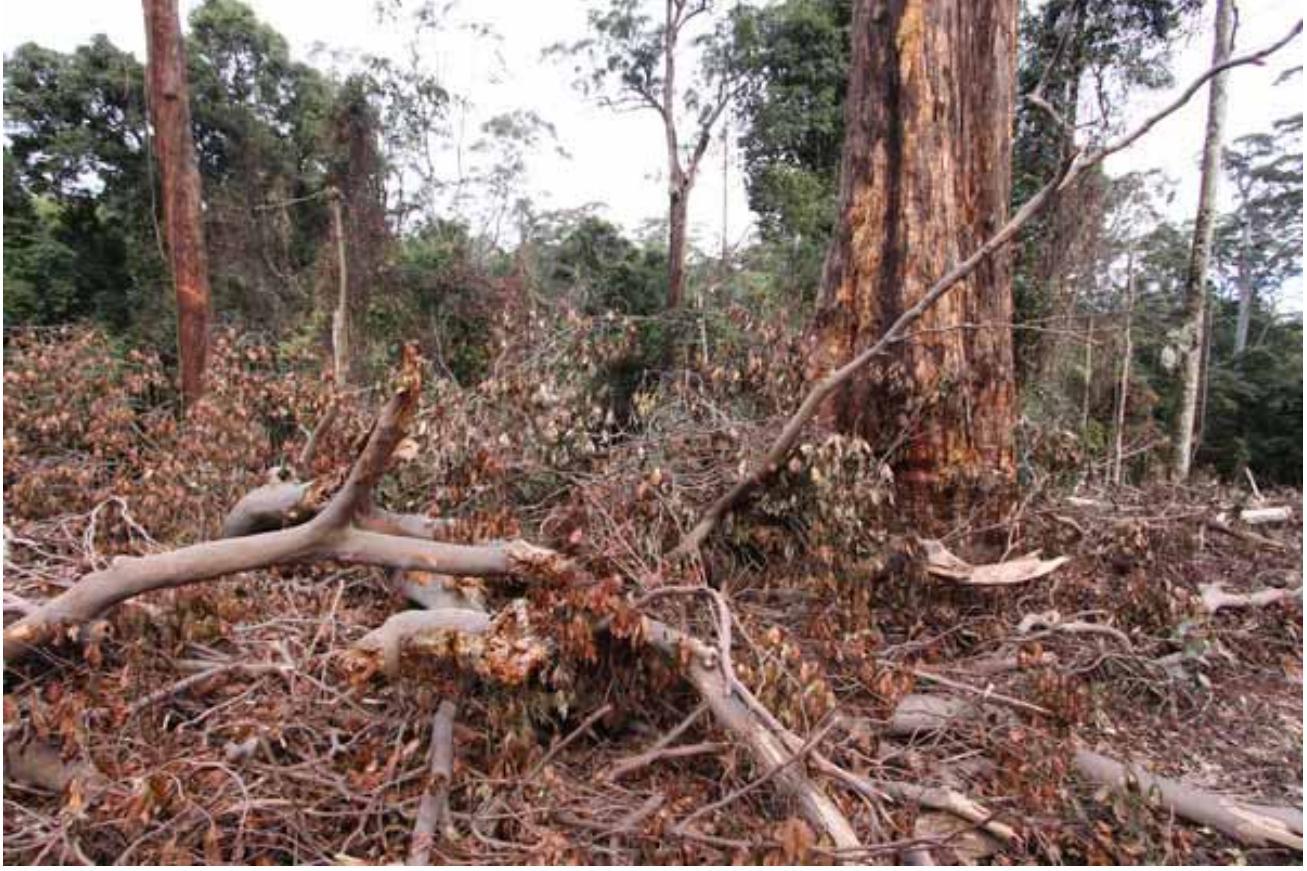
PHOTO 5: with a 2.48 metre diameter this Tallowwood was the largest tree measured in the stand. It is likely to be over a thousand years old. Unfortunately, contrary to licence requirements, large volumes of debris were pushed against its base, creating a funeral pyre waiting for the post-logging burn.

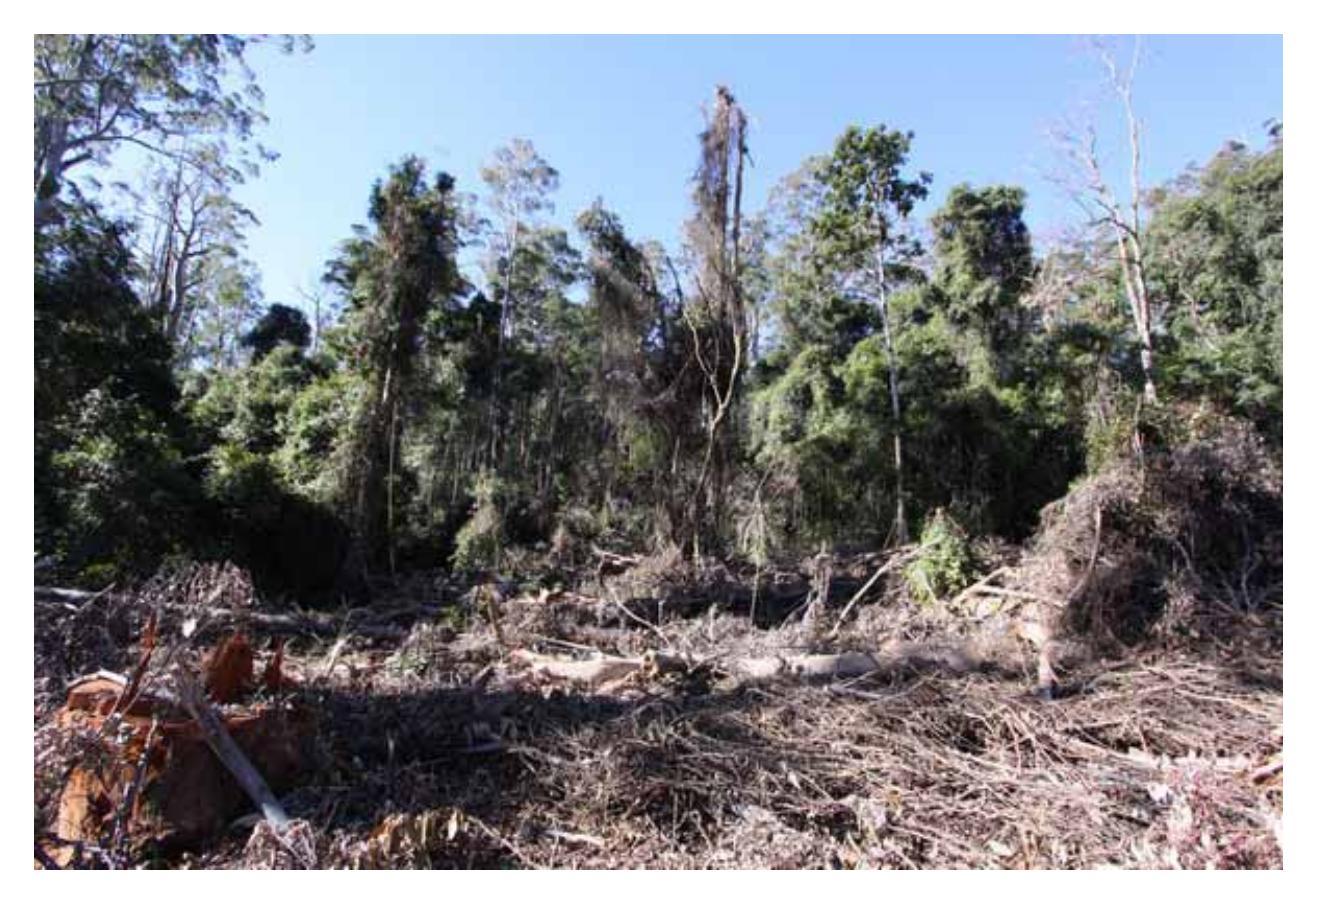
PHOTO 6: An area of excessive tree removal adjoining the FMZ3A exclusion area.

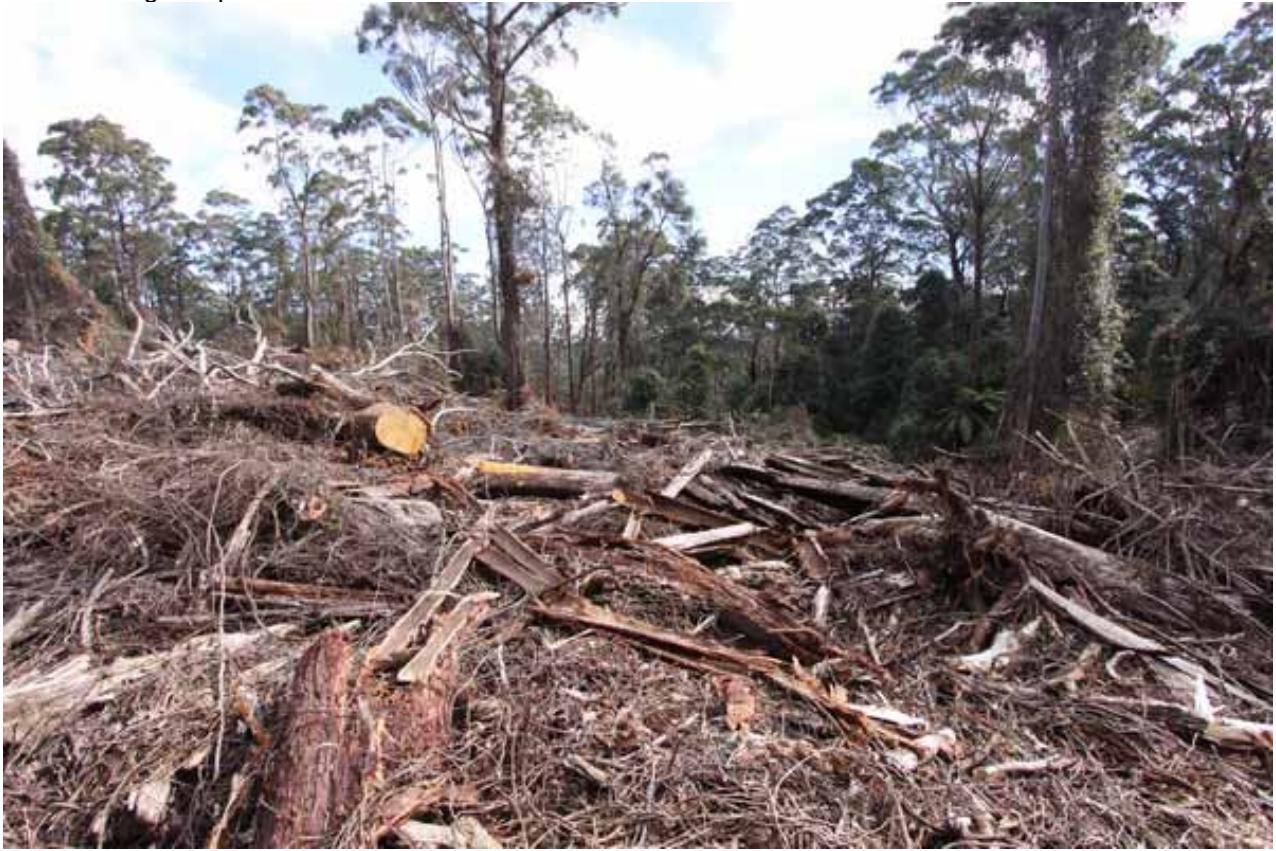
PHOTO 7: Logging in the wildlife corridor section of the FMZ3B area. A drainage depression has been trashed to right of photo.

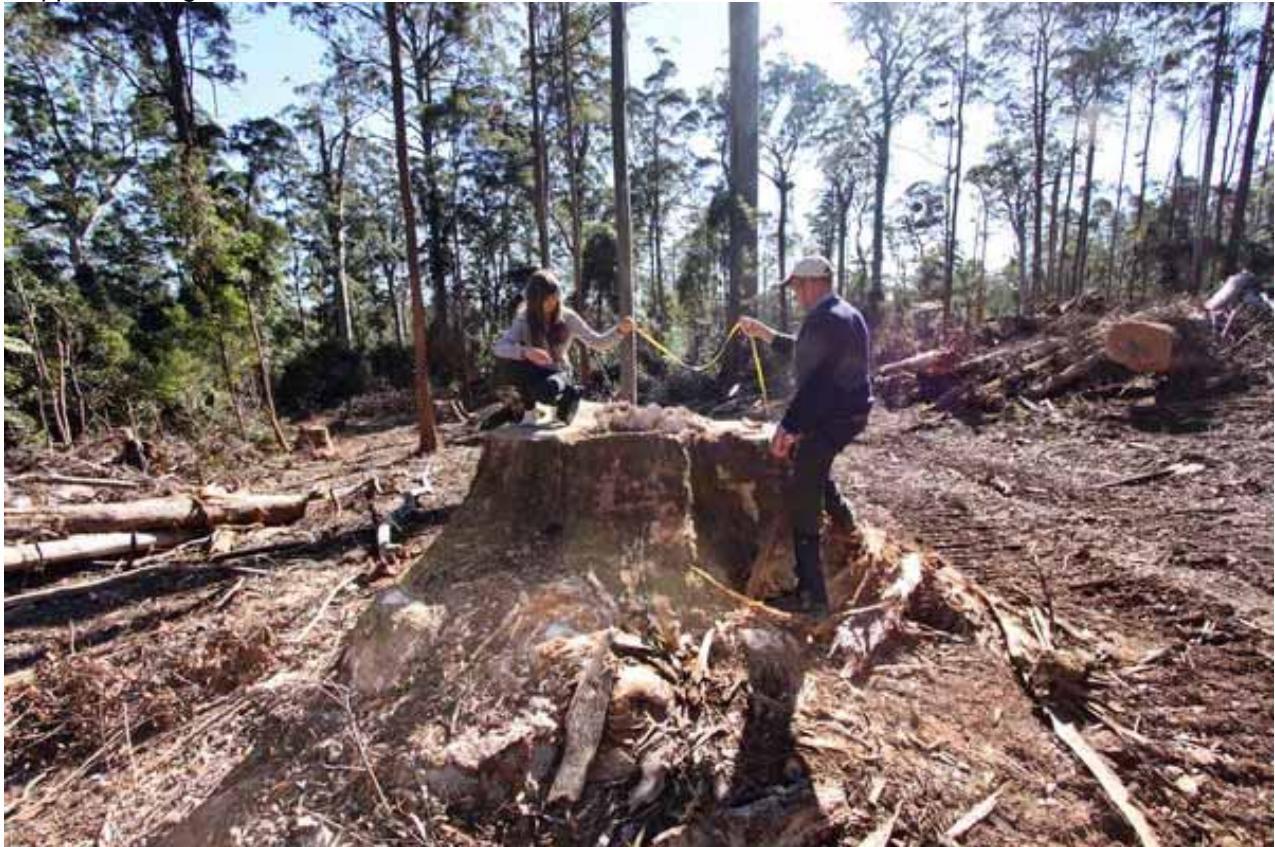
PHOTO 8: Measuring a Brush Box tree just under 2m in diameter illegally felled in the buffer of a trashed mapped drainage line within the FMZ3B area.

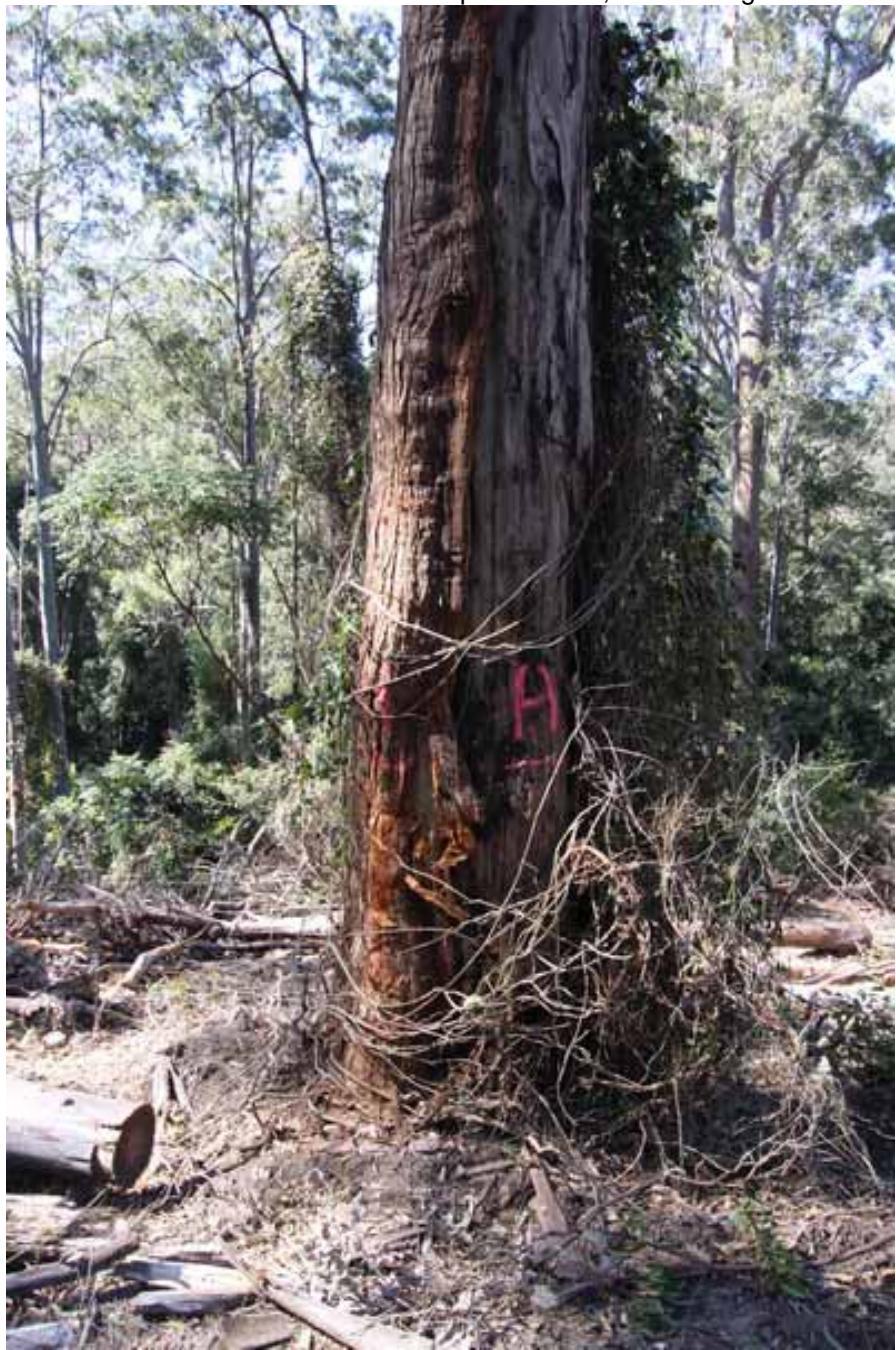
The audit area is situated within 200m of 4 Yellow-bellied Glider observation records. Across the 3.7 ha audit area, and the adjoining modified harvesting areas for Yellow-bellied Gliders, not a single tree was observed to be marked as a feed tree. In this area mature to late mature Blue Gums are the principal species required to be retained to satisfy prescriptions, though retention of these trees was inadequate and trees required to be retained were logged. PHOTO 9: Marked habitat tree in Compartment 53, note the significant damage.

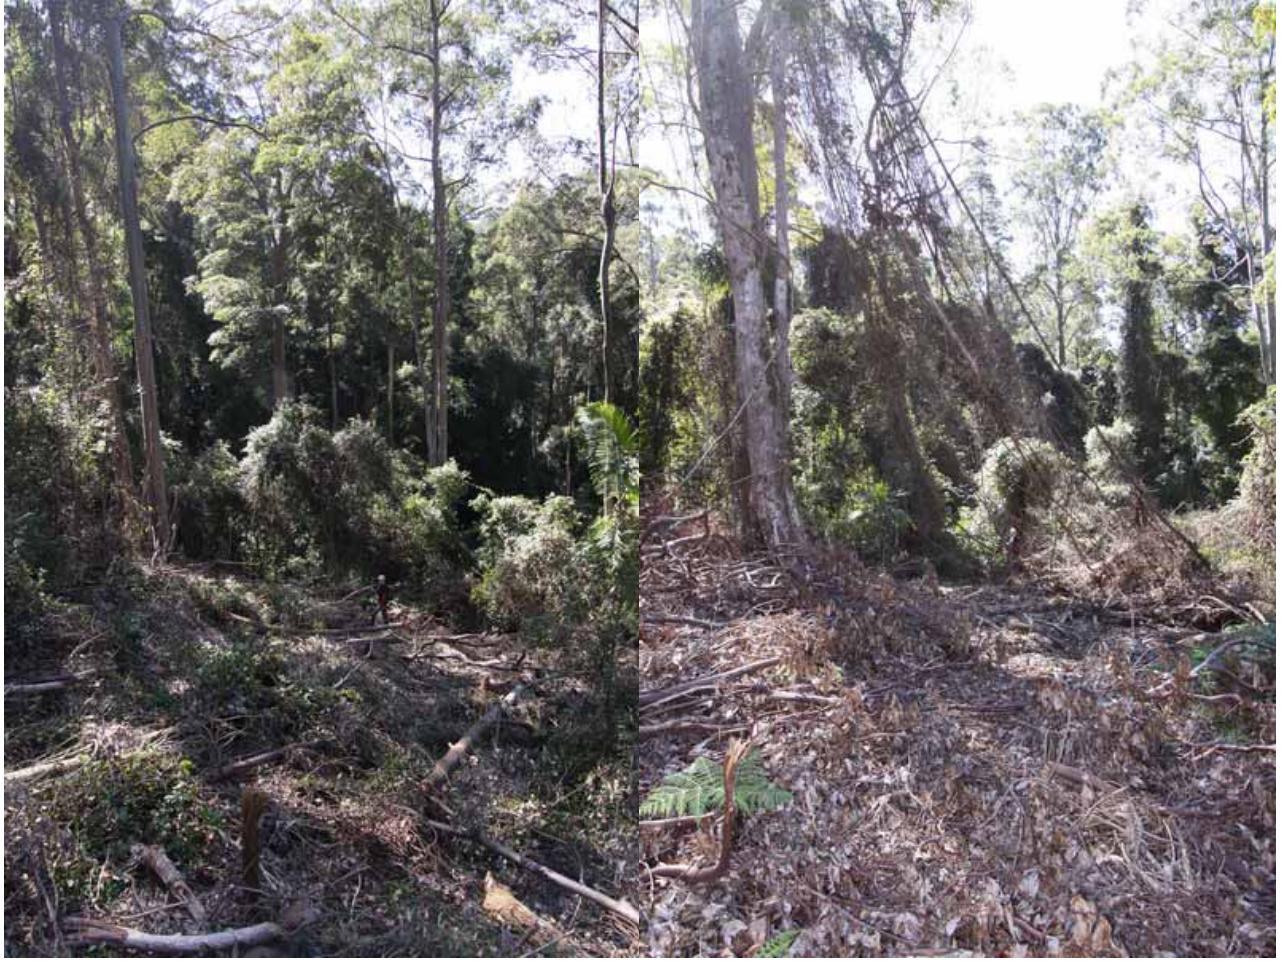
In the case of the Stuttering Frog a 30m exclusion buffer is required to be applied to all streams within 200m of the record. Rather than being applied from the centreline of mapped streams (as is done in harvesting plans and on the above map) it needs to be measured and marked from the stream bank to satisfy the TSL condition 6.3 (b):

PHOTOS 10&11: 2 incursions into 30m exclusion zone required to be implemented for Stuttering Frog. Note the person standing on the edge of the bank in both photos from which the buffer is meant to be applied. In the photo to the left large numbers of trees have been deliberately felled into the exclusion. In the photo on the right debris (at base of vines) was pushed into the exclusion area. No attempt had been made to mark the boundary of the exclusion zones.

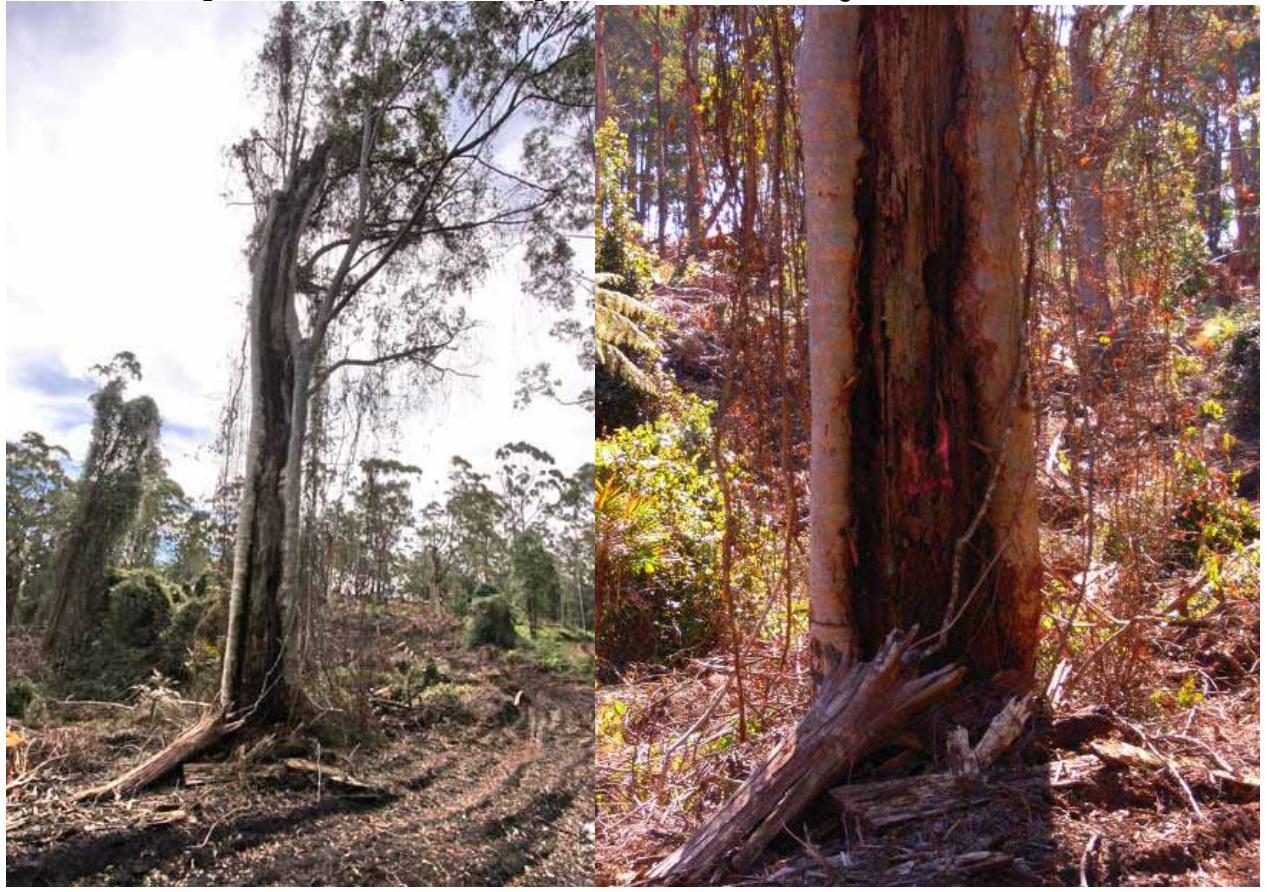
Inappropriate trees were found to be marked for retention. One (in the Special Prescription Area) had no hollow, was incapable of developing them and had debris stacked so as to ensure it burnt down in the post-logging burn (photo 12). Many retained trees have

PHOTOS 12&13: Tree retained as habitat tree in wildlife corridor section of FMZ3B zone, aside from being half dead the tree had no hollows and is now incapable of forming them (GDA 432641, 6797203). Note the debris stacked against base ready for burning and the extensive damage to the wildlife corridor behind.

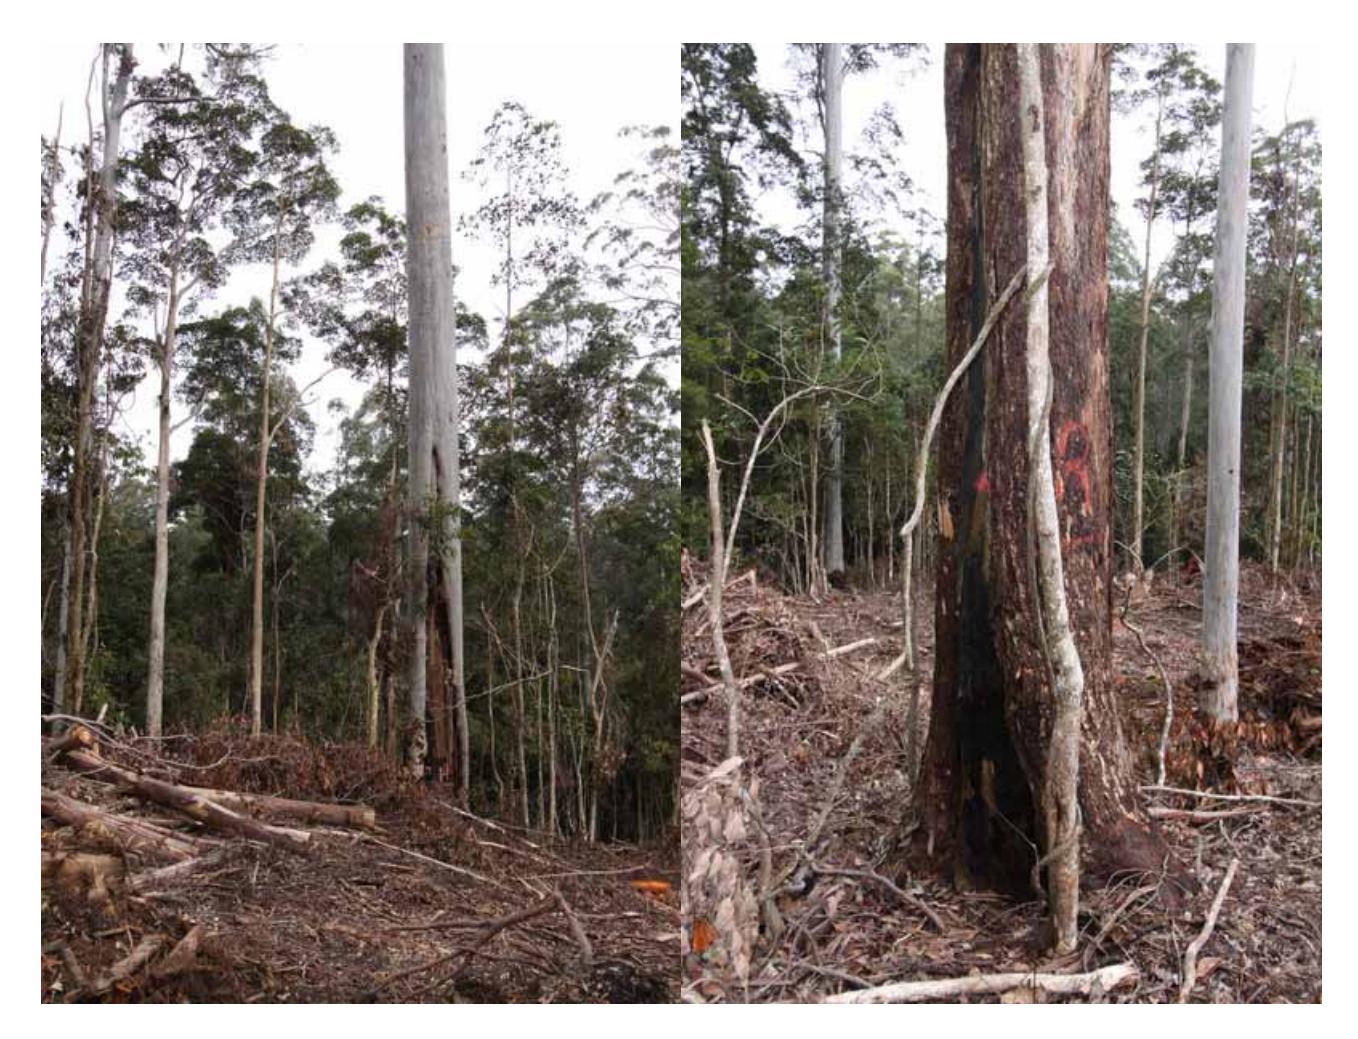
PHOTOS 14&15 Trees retained (outside audit area) in FMZ3B zone, note the significant butt damage.

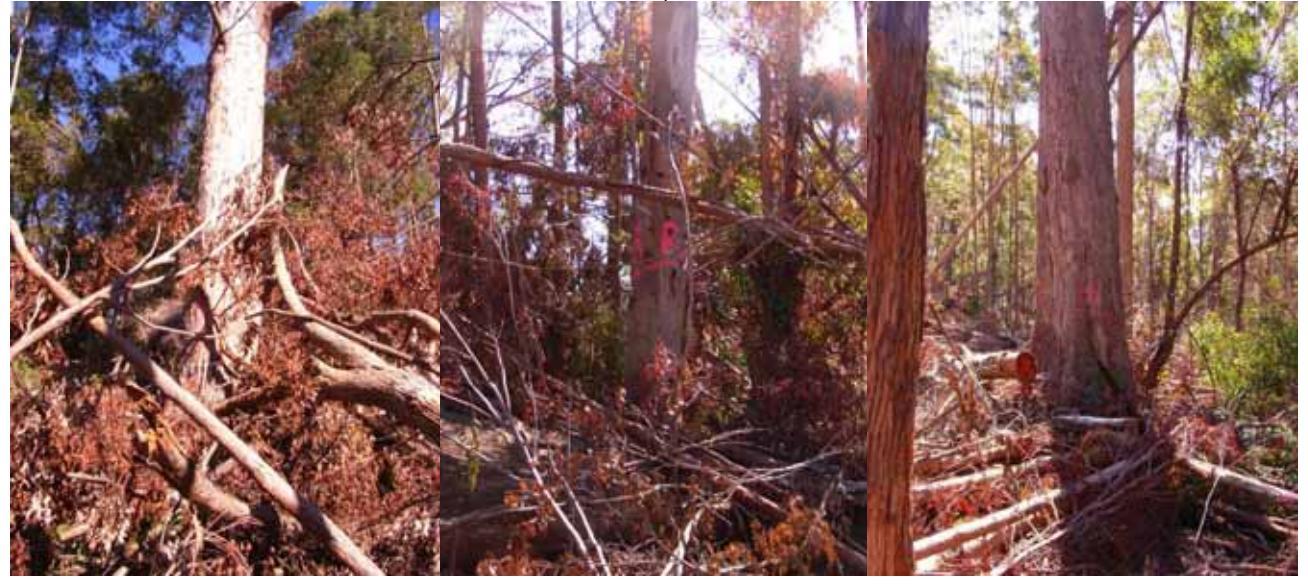
PHOTOS 16, 17 &18:Other examples of Habitat and recruit trees with debris stacked against bases (GDA 431007_6797482, 430993_6797485, 431017_6797358)

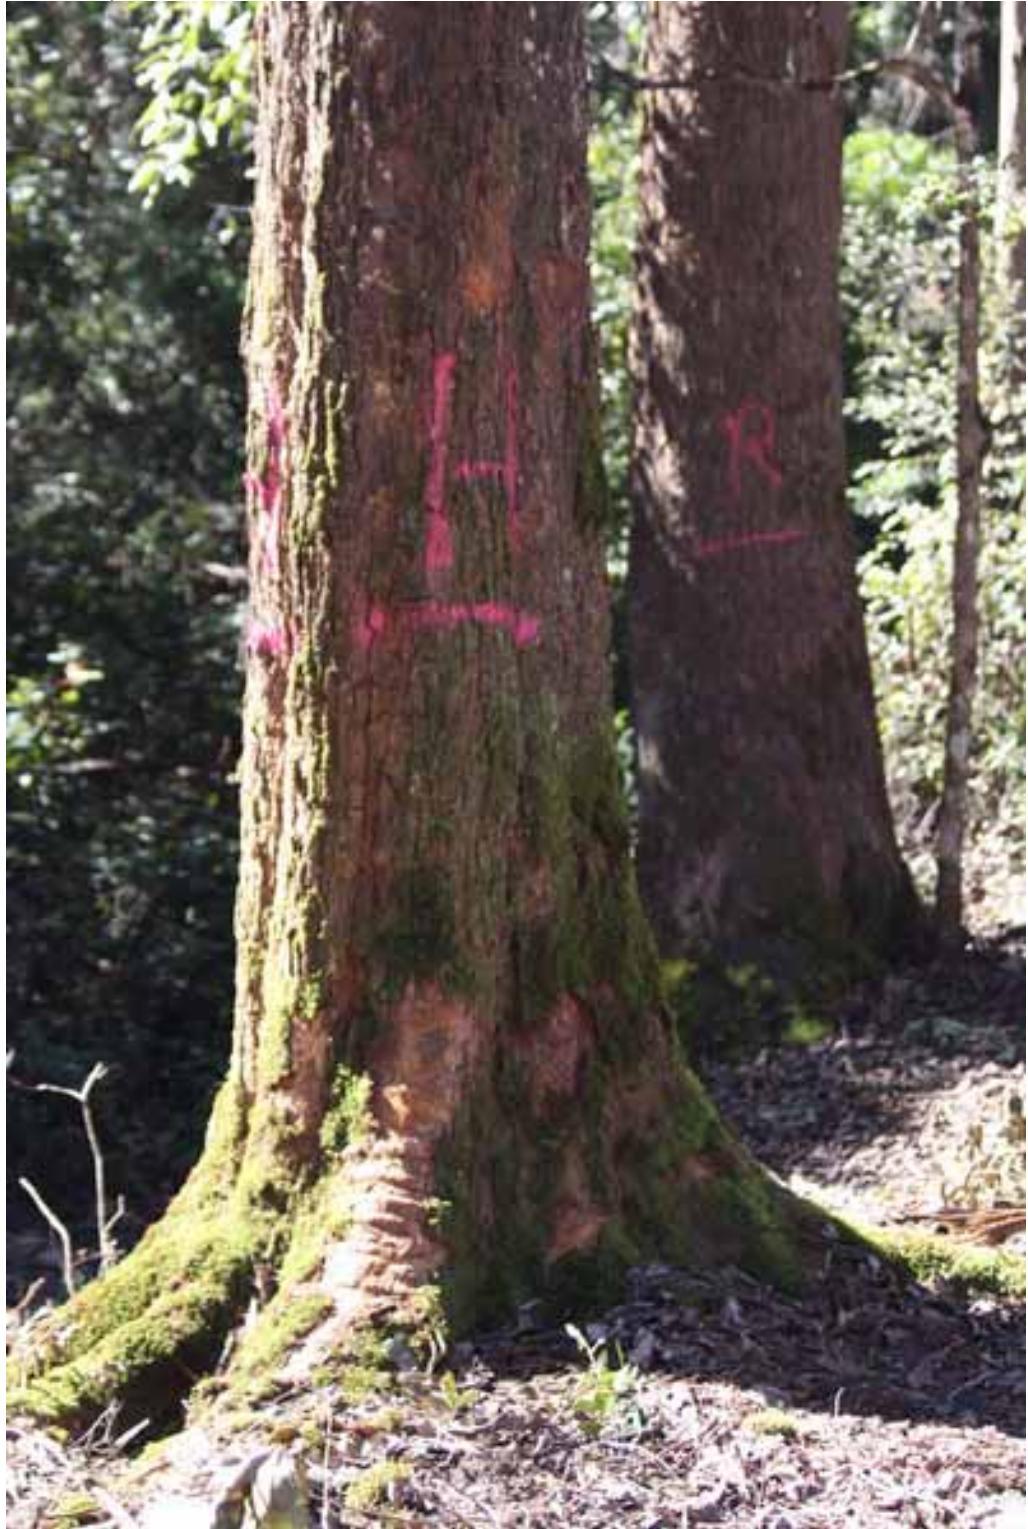
At places in compartments 44 and 45 habitat and recruitment trees are marked within filter strips along unmapped drainage lines. In some cases the same tree is both marked as a recruitment tree and the boundary of the exclusion area. Forests NSW maintain that even when exclusion zones are applied to unmapped drainage lines they remain part of the net harvest area (this may be why they refuse to allocate FMZ8 to the appropriate exclusion

zone). Forests NSW therefore use trees in these areas to meet habitat tree requirements, which can be contrary to requirements to retain habitat trees scattered throughout the logging area.

PHOTO 19: Trees marked as habitat and recruitment trees within marked filter strip on bank of unmapped drainage line in Compartment 45, these were 2 of 9 trees marked within close proximity (GDA 431183, 6797494).

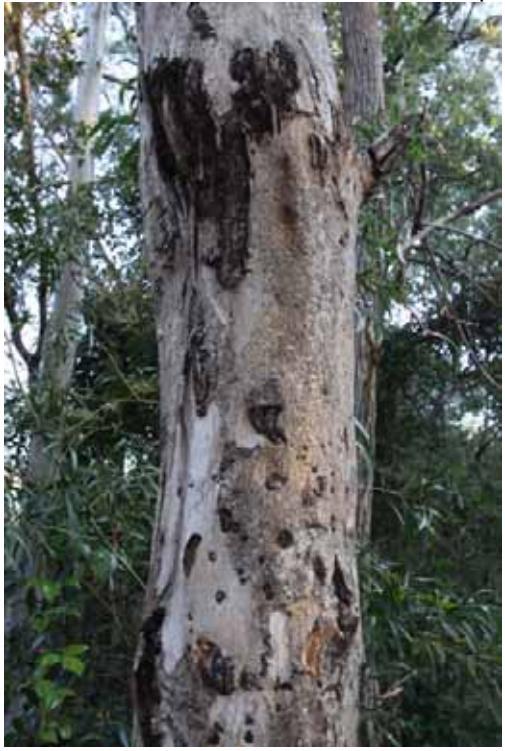
PHOTO 20: Old Yellow-bellied Glider sap feed tree Compartment 53

A search in the vicinity of this sap feed tree and the area representing the combination of 200m modified logging buffers around the cluster of 5 observation records in compartment 55 were searched for trees marked as Yellow-bellied Glider feed trees. In contravention of TSL 6.17(g)iv not a single tree was found to be marked for this purpose and marking for habitat and recruitment trees was found to be deficient. It appeared that the required numbers of feed trees were not retained in these areas, particularly as compliance with the prescription would have precluded removal of Blue Gums throughout much of these areas. It appears that TSL6.17 (g) was not complied with in any part.

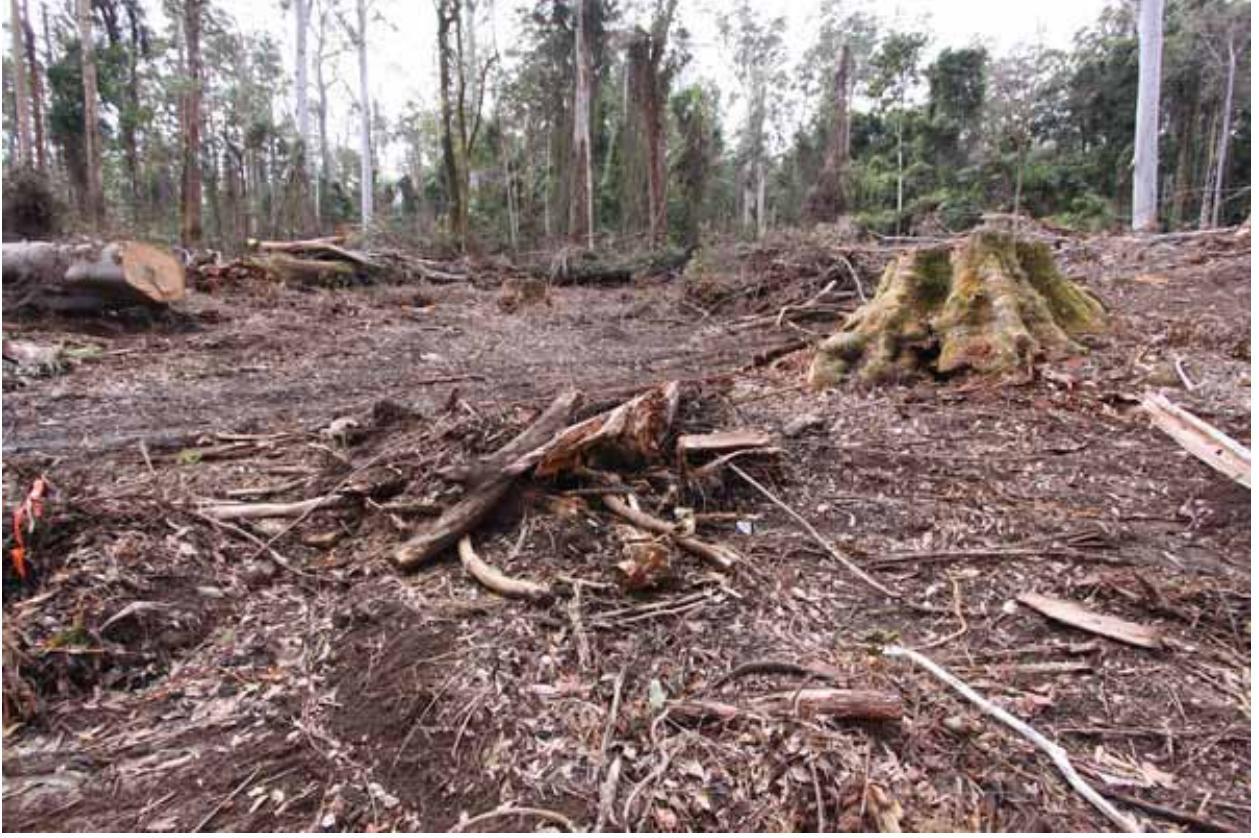
PHOTO 21: Trashed mapped drainage line from bottom left to centre top, FMZ3B area in Compartment 44 (TDF1, App5.3). There was no marking (remaining) and at least 3 large trees and many rainforest trees and shrubs had been removed, the intensive disturbance precluded any identification of what used to be there.

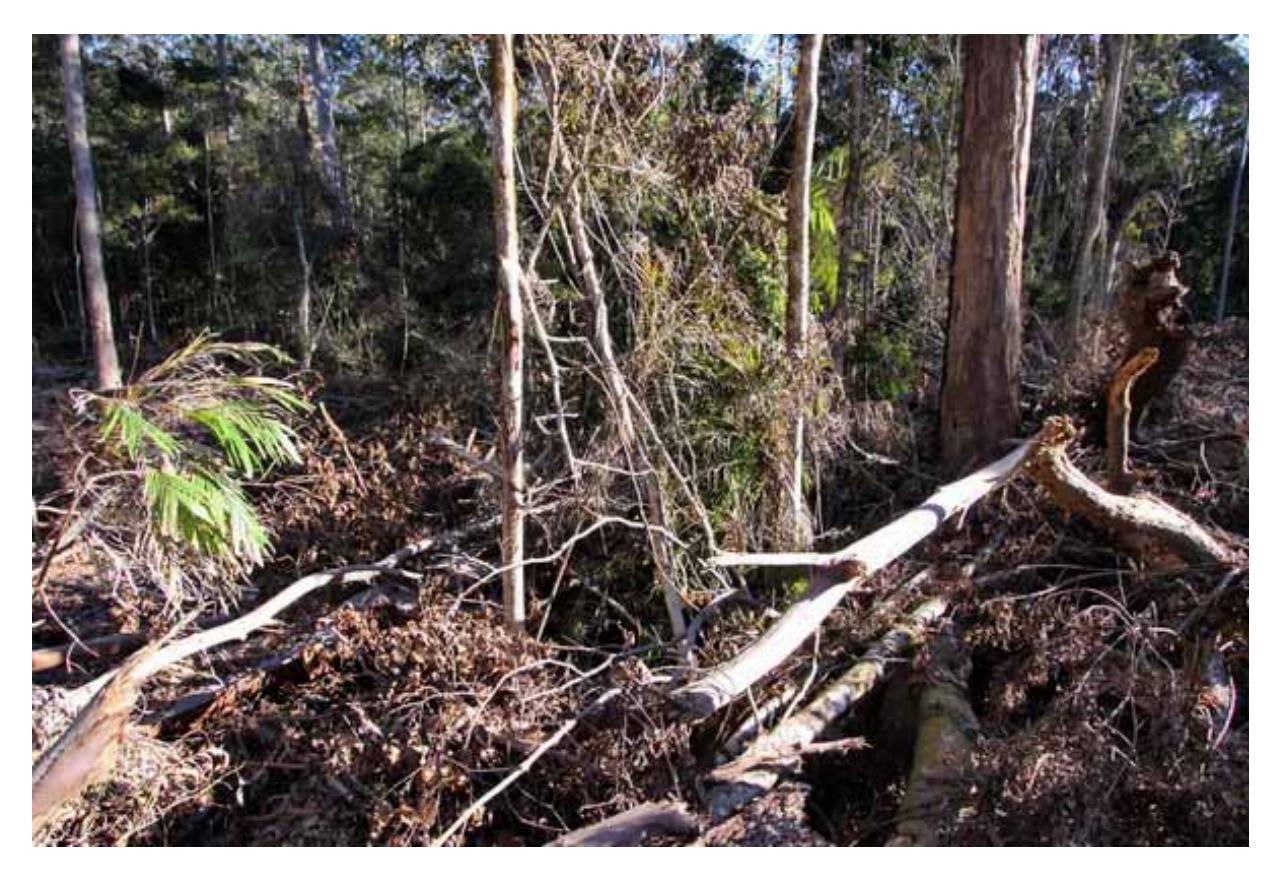
PHOTO 22: Unmapped Drainage Line in FMZ3B area in Compartment 44 (TDF2, App5.3). The large tree on the right has two bars at right of base, the centre of the stream is in the centre of photo.

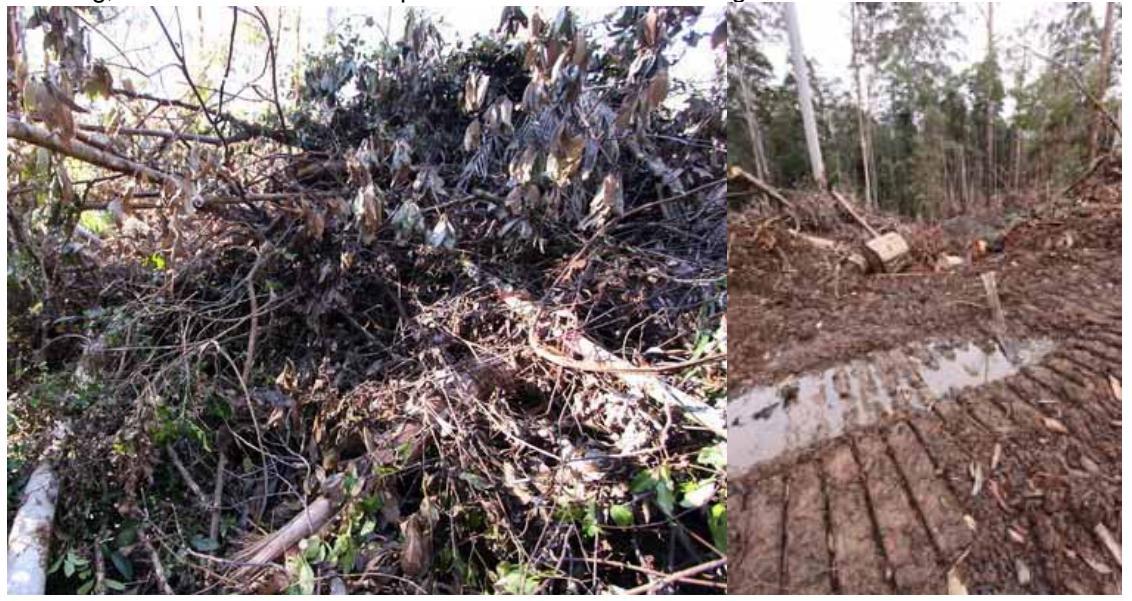
PHOTOS 23&24: Unmapped Drainage Line in FMZ3B area in Compartment 44 (TDF2, App5.3). Left photo: debris pile located to the left of above photo, mixed in with debris (centre right) is a sapling marked with two bars, indicating other side of drainage line somewhere in vicinity. Right photo: looking down stream from crossing, note the billets and soil pushed into centre of drainage feature.

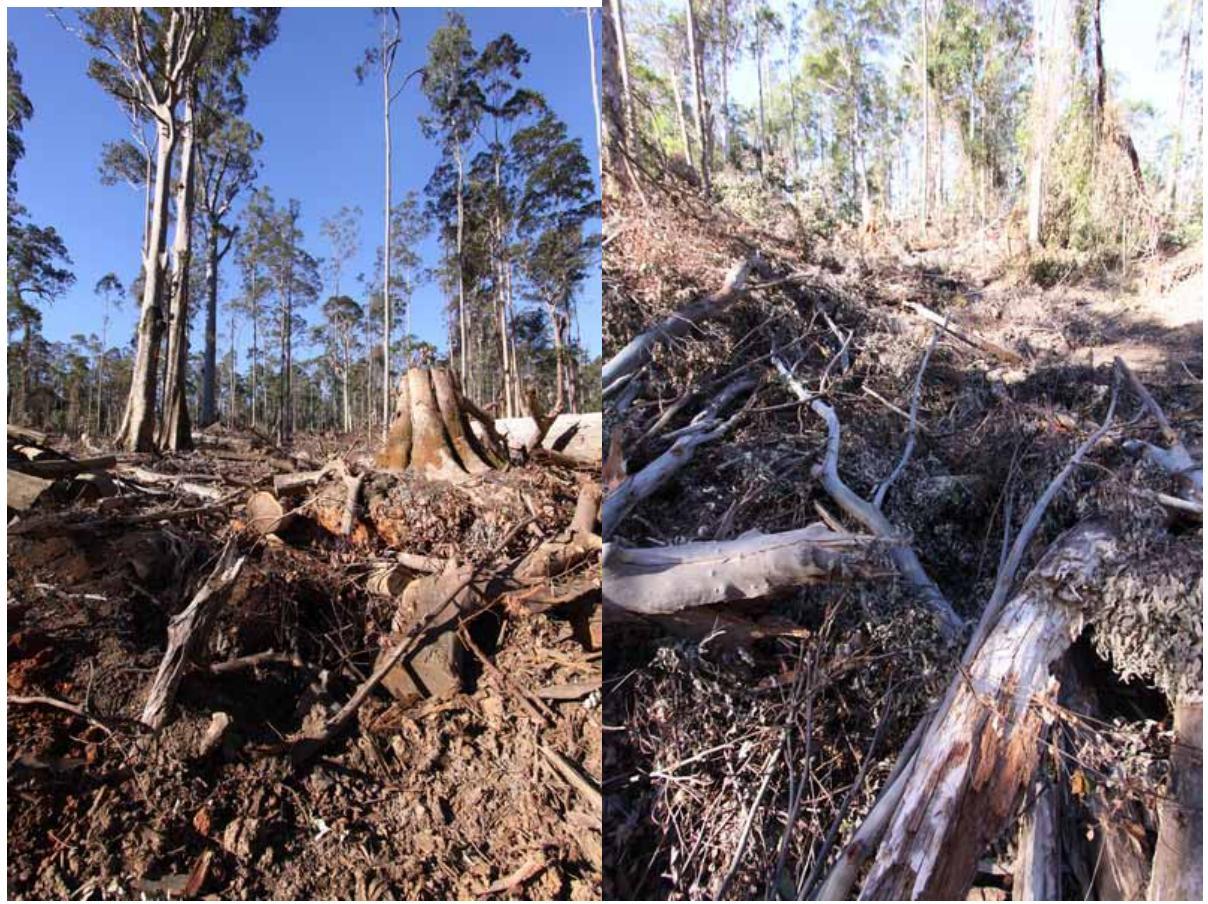
PHOTOS 25&26: Unmapped Drainage Line in FMZ3B area in Compartment 44 (TDF2, App5.3). Note that whole tree stumps and large volumes of debris have been bulldozed into the drainage line.
