PRELIMINARY AUDIT OF GIRARD STATE FOREST COMPARTMENTS 44, 45, 46, 54, 55 and 56

Dailan Pugh, August 2010 For North East Forest Alliance

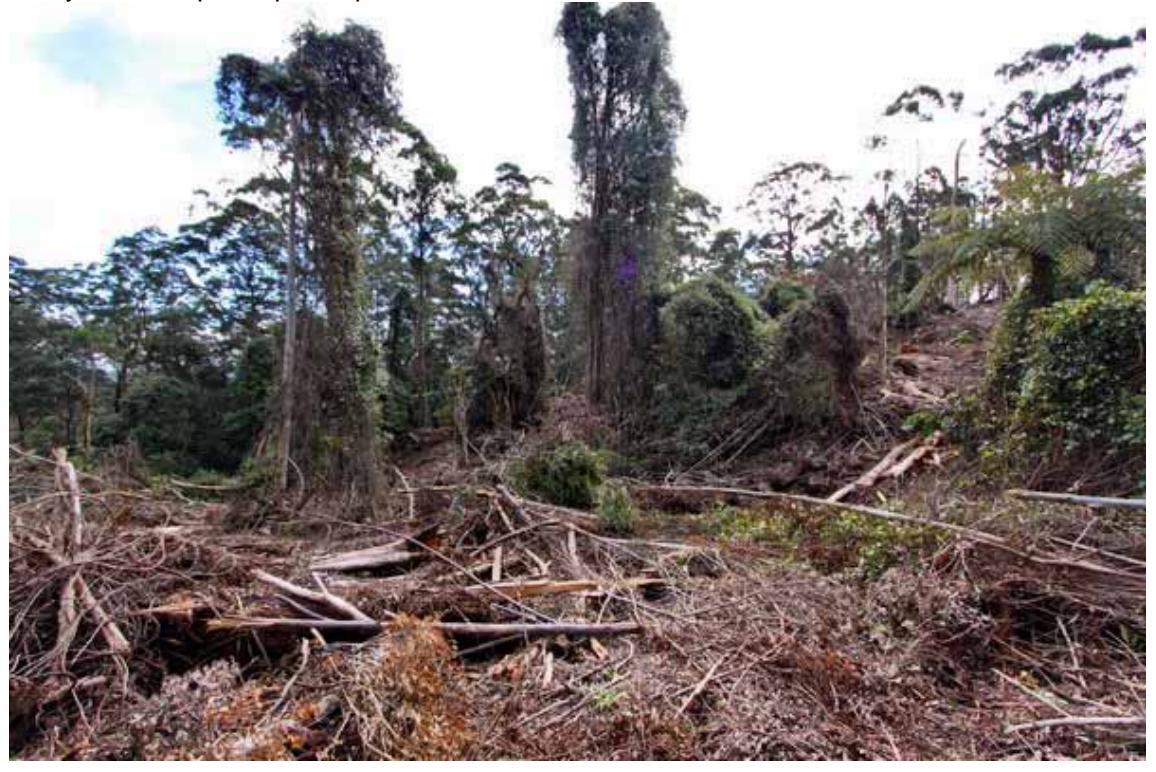
PHOTO 27: Trashed drainage depression in wildlife corridor section of FMZ3B area in compartment 44 (TDF3, App 5.3). As well as being cleared and filled with debris there was significant machinery disturbance. Lucky this is a special prescription area!

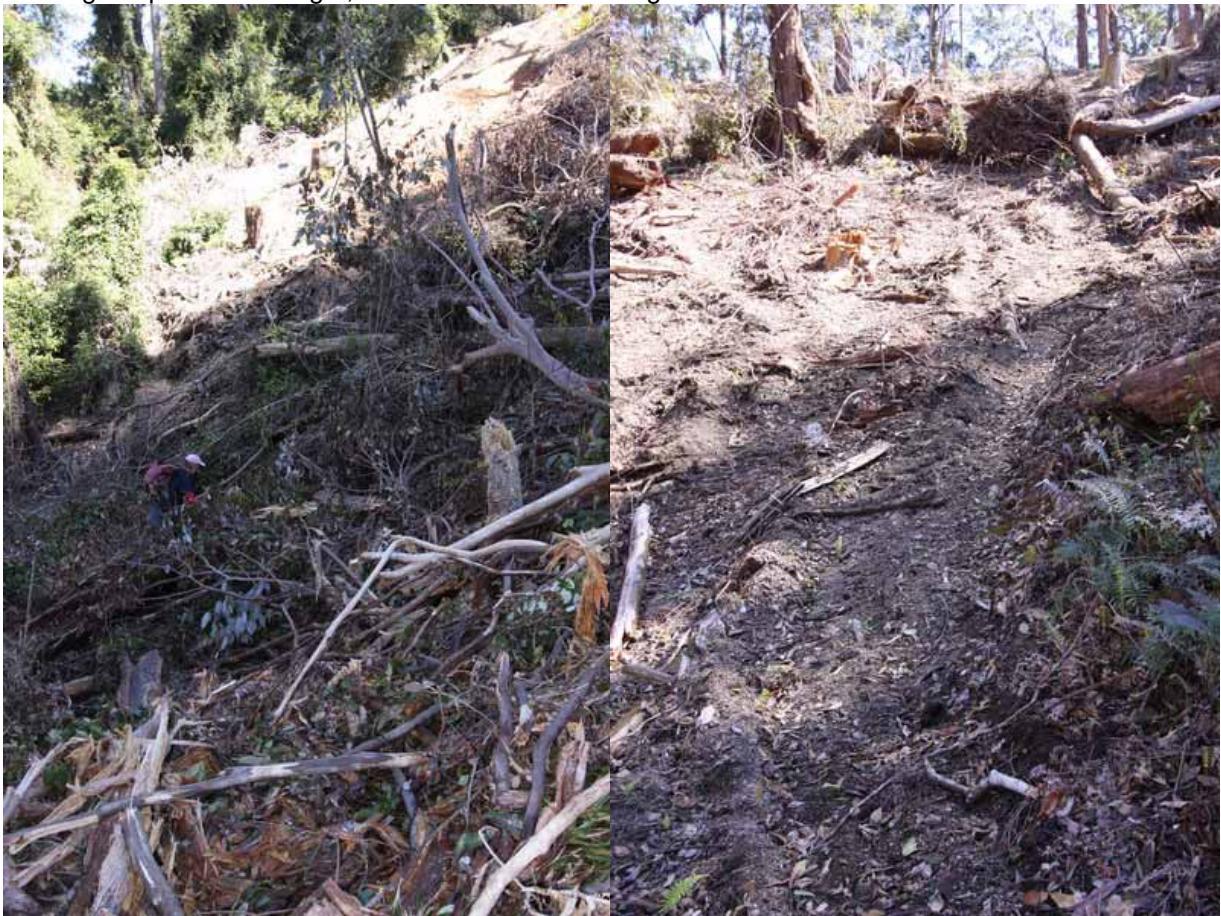
PHOTOS 28&29: Compartment 55 Drainage line on left, note the person standing in centre of stream. Drainage depression on right, note extensive bulldozing of bed.

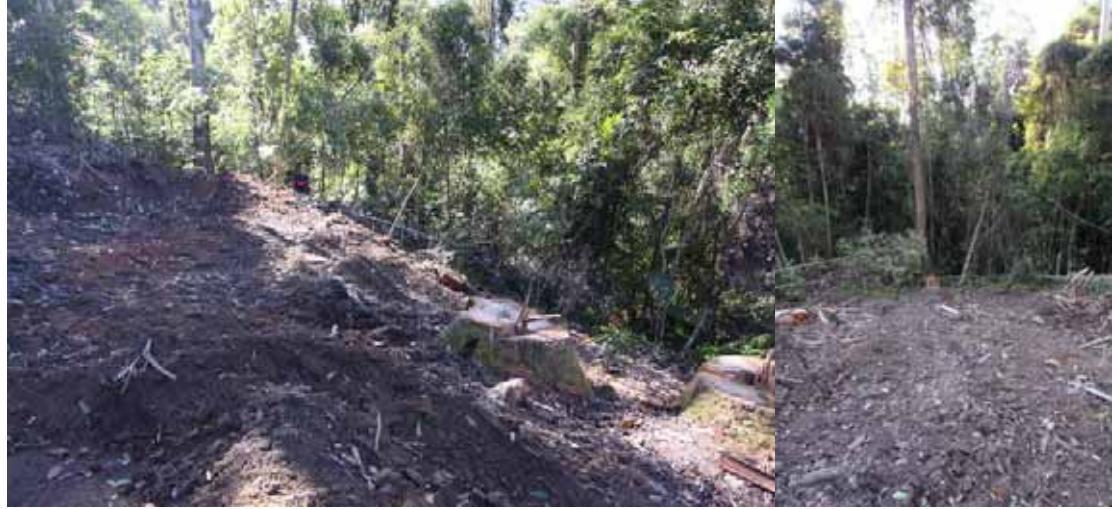
PHOTOS 30&31: First is pad constructed for harvesting within operational zone of unmapped drainage line in compartment 55, with spoil extending within buffer zone to 8.4m from centre of drainage line (person standing at base of spoil). Second is incursion into operational zones of marked unmapped drainage line in compartment 44, extending into the buffer zone 8m from stream. Note lack of any remediation.

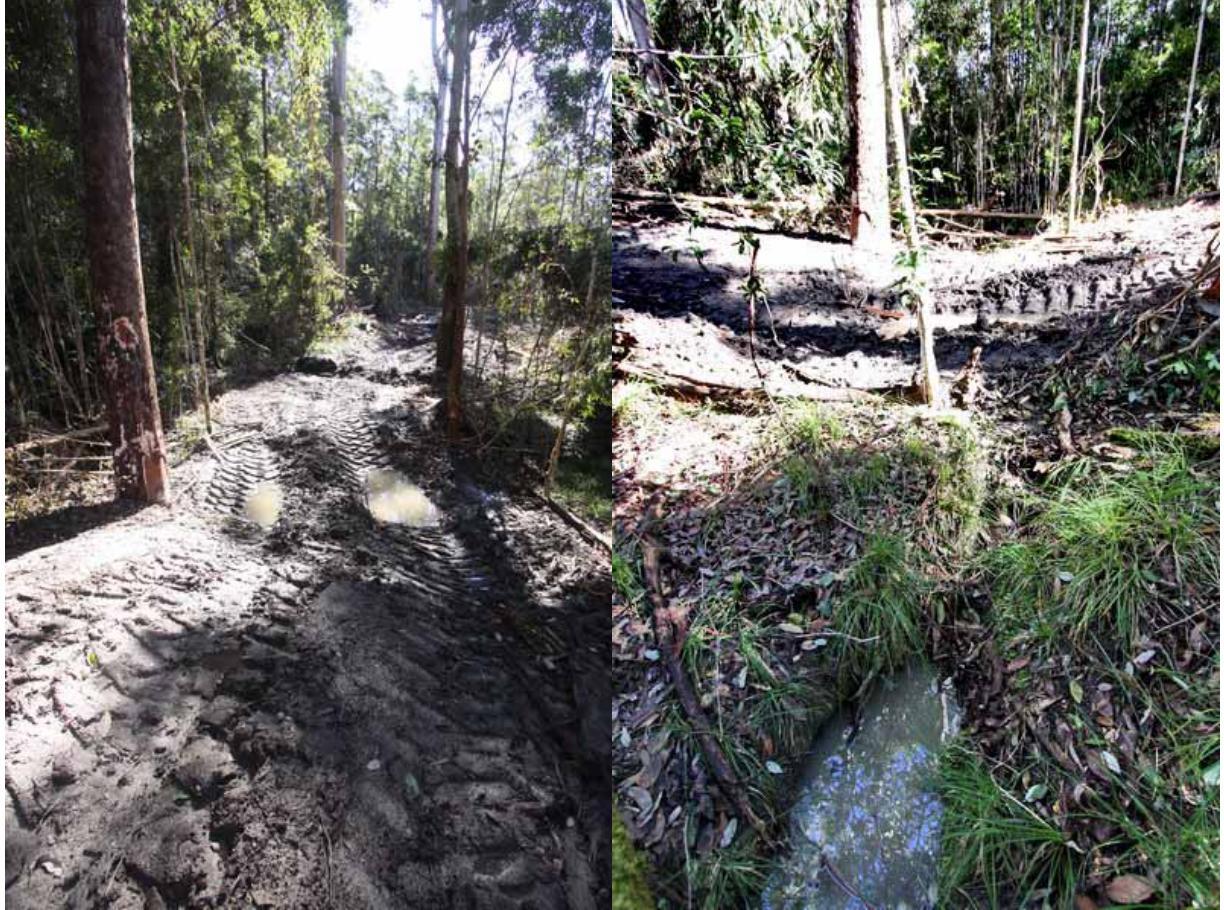
PHOTOS 32&33: Crossings of unmapped drainage line in compartment 45 (UDC3, App5.3). Two crossings were made 57 metres apart (also UDC2) despite only one crossing being needed. The creek was still flowing but there had been no attempt to rehabilitate the crossings.

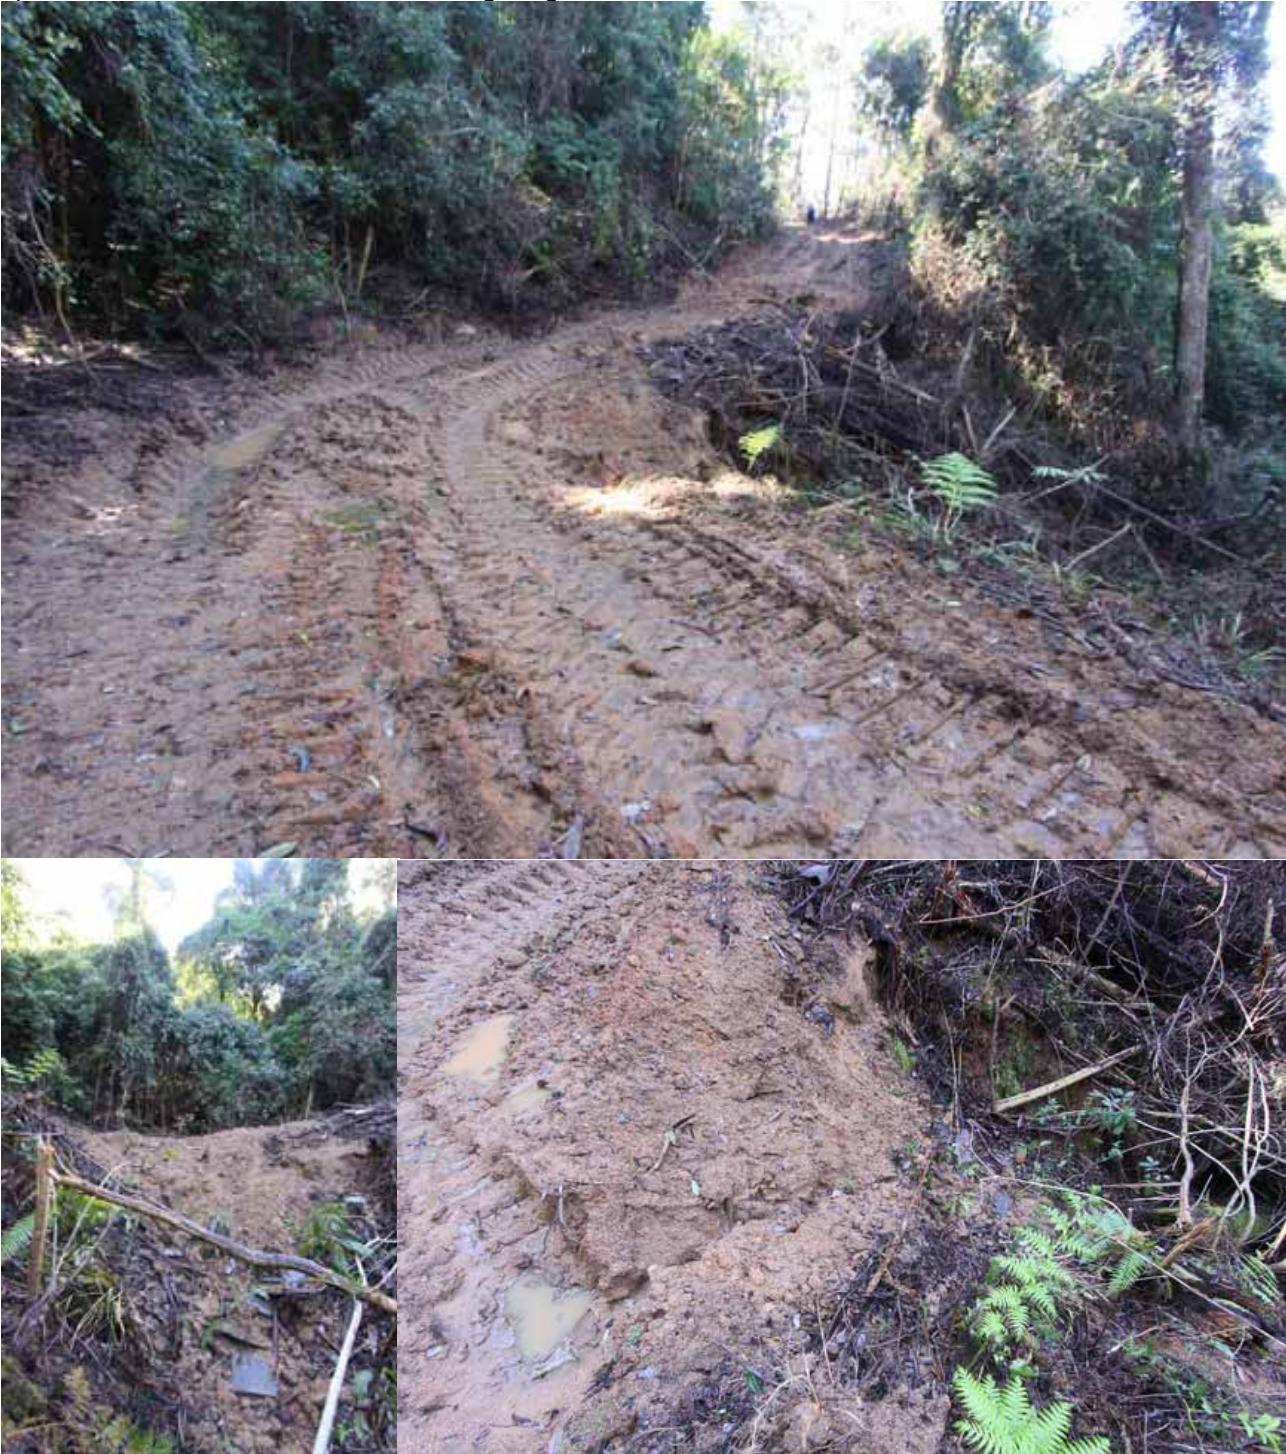
PHOTOS 34,35&36: Track constructed across head of drainage line in Compartment 5 (UDC5, App5.3, Breach 13, App5.4). This breach was identified by Forests NSW in April and use of the track has long since finished. Note the lack of any remediation aside from cross banks and the initiation of erosion. This is upstream from the record of the Stuttering Frog and about 50m above its exclusion zone.

In relation to UDC4 and UDC5 (Photos 34, 35, 36), these were identified by Forests NSW (App 5.4. no13) as breaches in April with the comment "*Bulldozer driver opening old road for snig track, pushed through 2 unmapped drainage lines*", though were excused on the basis of "*New to the job and didn't understand the licence*". Despite large amounts of fill being pushed into the drainage lines and both crossings being situated upstream (50-80m) from a Stuttering Frog exclusion zone, Forests NSW concluded that there was no

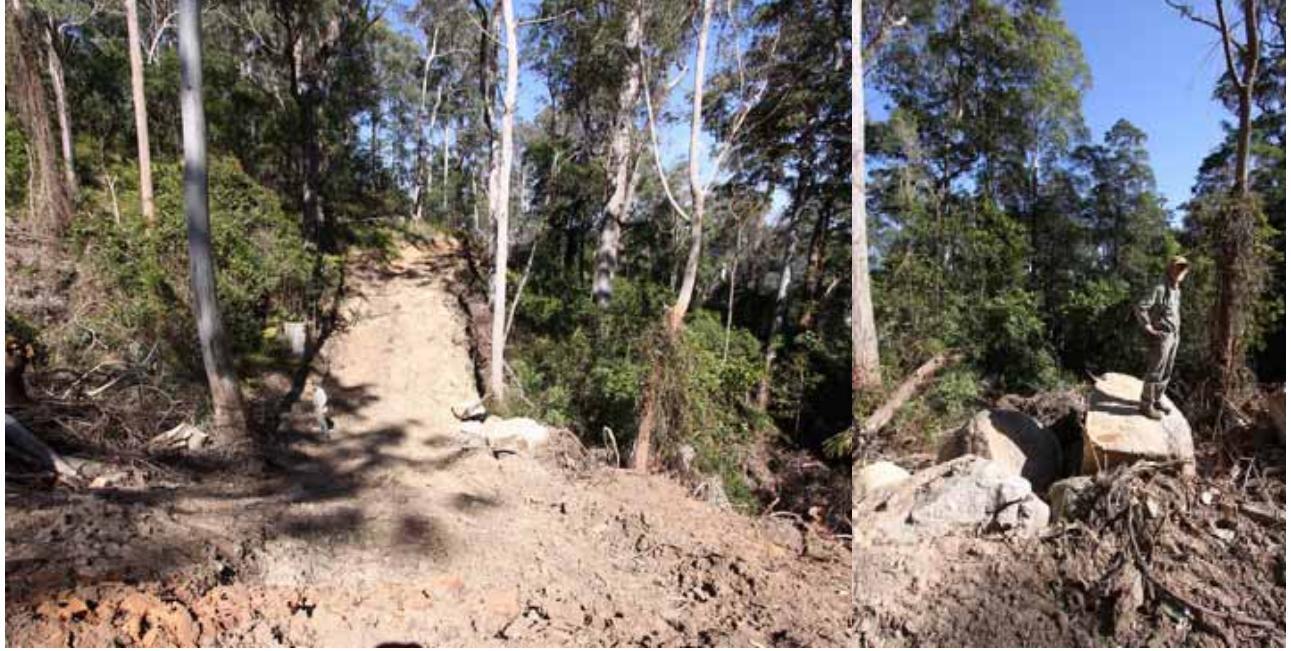
PHOTOS 37&38: Crossing across drainage depression at head of deep gully in compartment 55 ((UDC6, App5.3). Note the excessive unrehabilitated soil disturbance and the boulders (with person standing on them) pushed into centre of stream.
